# UNDERWATER BRIDGE INSPECTION REPORT

STRUCTURE NO. 07569

BLUE EARTH RIVER

MINNESOTA DEPARTMENT OF TRANSPORTATION  
UNDERWATER BRIDGE INSPECTION

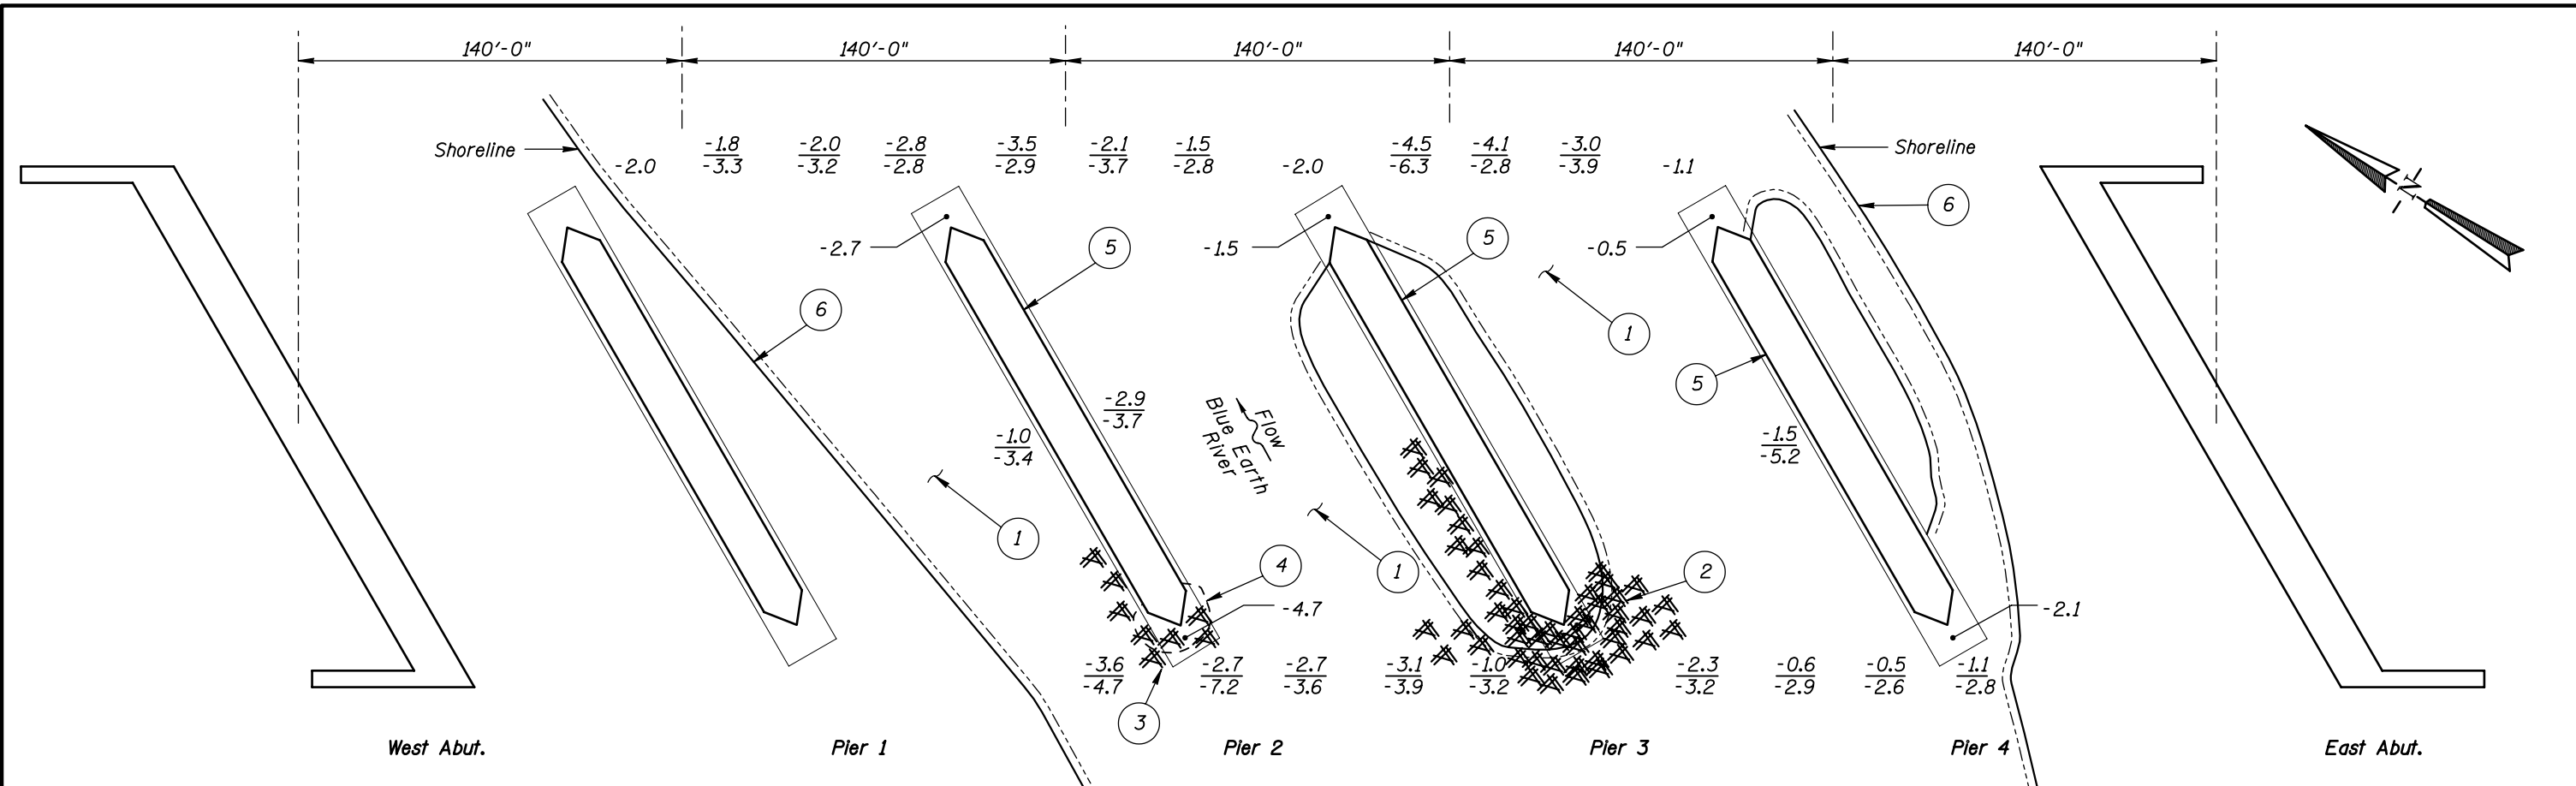
- The channel bottom material around the substructure units consisted of sand, gravel, cobbles, and 1 foot diameter riprap with up to 1 foot of probe rod penetration.
- Heavy accumulation of timber debris, with pieces up to 2 feet in diameter, was observed around the upstream nose and along the west face up to the midpoint of Pier 3. The timber debris consisted of up to 2 foot diameter logs and extended from the channel bottom to 15 feet above the waterline.
- Moderate accumulation of timber debris was observed around the upstream nose and along the west face of Pier 2.
- Scour depression with a 7 foot radius and 1.5 feet of depth was observed around the upstream nose of Pier 2.
- Overall the concrete of the piers was in good condition and only exhibited random vertical hairline cracks.
- Vertical bank erosion was observed all along the river bank.

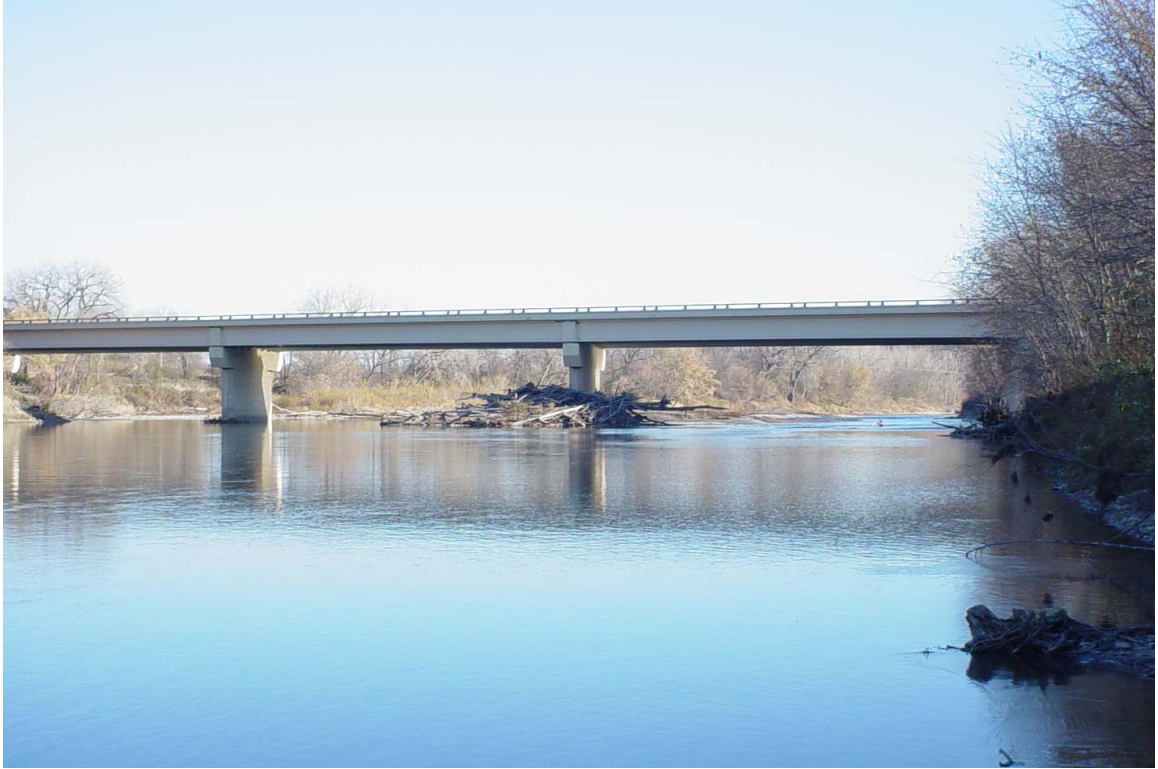
Photograph 1. Overall View of the Structure, Looking Northeast.

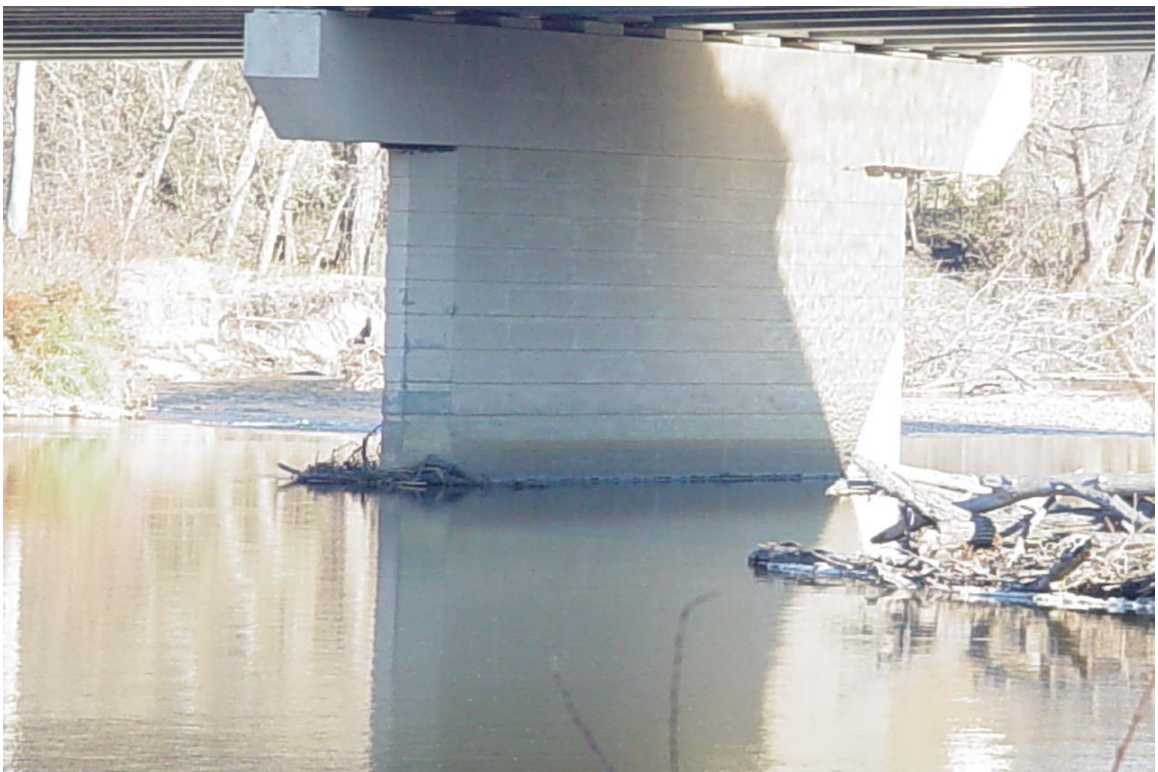
Photograph 2. View of Pier 2, Looking North. Note the Moderate Timber Accumulation.

- (A) Remove the accumulation of timber debris from around the upstream noses of Piers 2 and 3 before it progresses further and adversely affects the piers or their surrounding channel bottom.
- (B) Monitor the vertical erosion along the river banks and the scour hole around the upstream nose of Pier 2 during future inspections.
- (C) Reinspect the submerged substructure units at the normal maximum recommended (NBIS) interval of five (5) years.

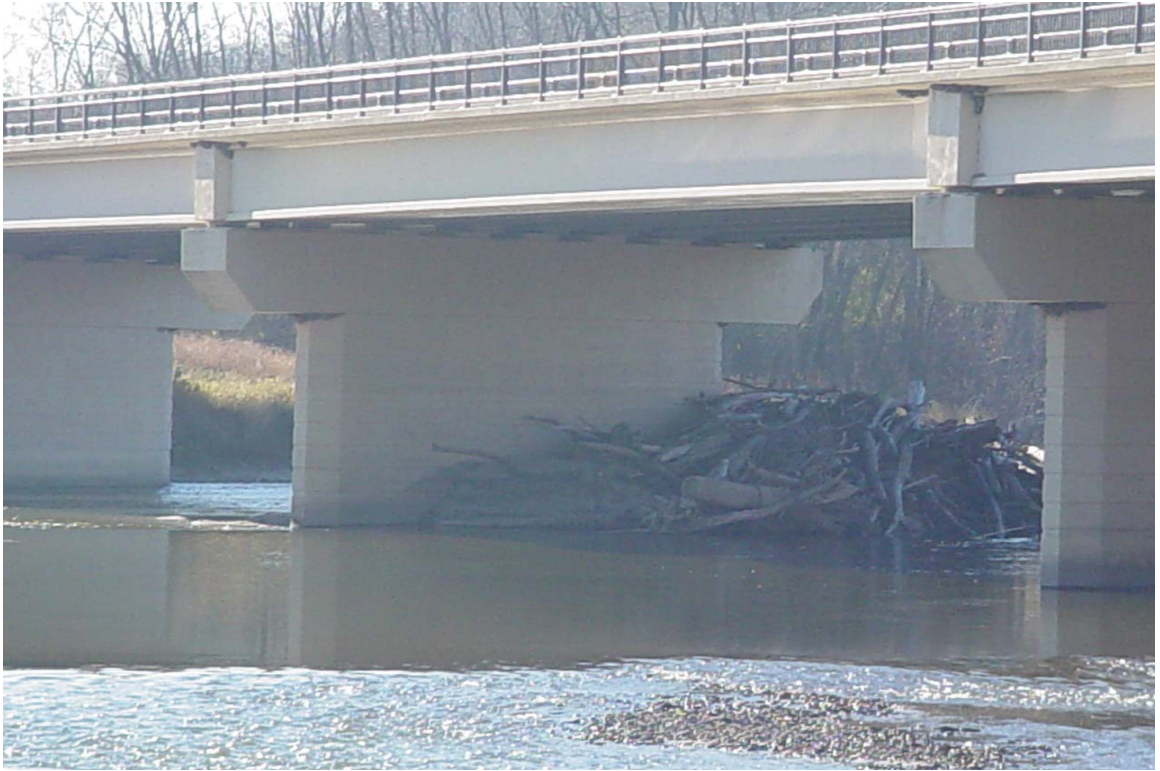
Photograph 3. View of Pier 3, Looking West. Note the Heavy Timber Debris Accumulation.

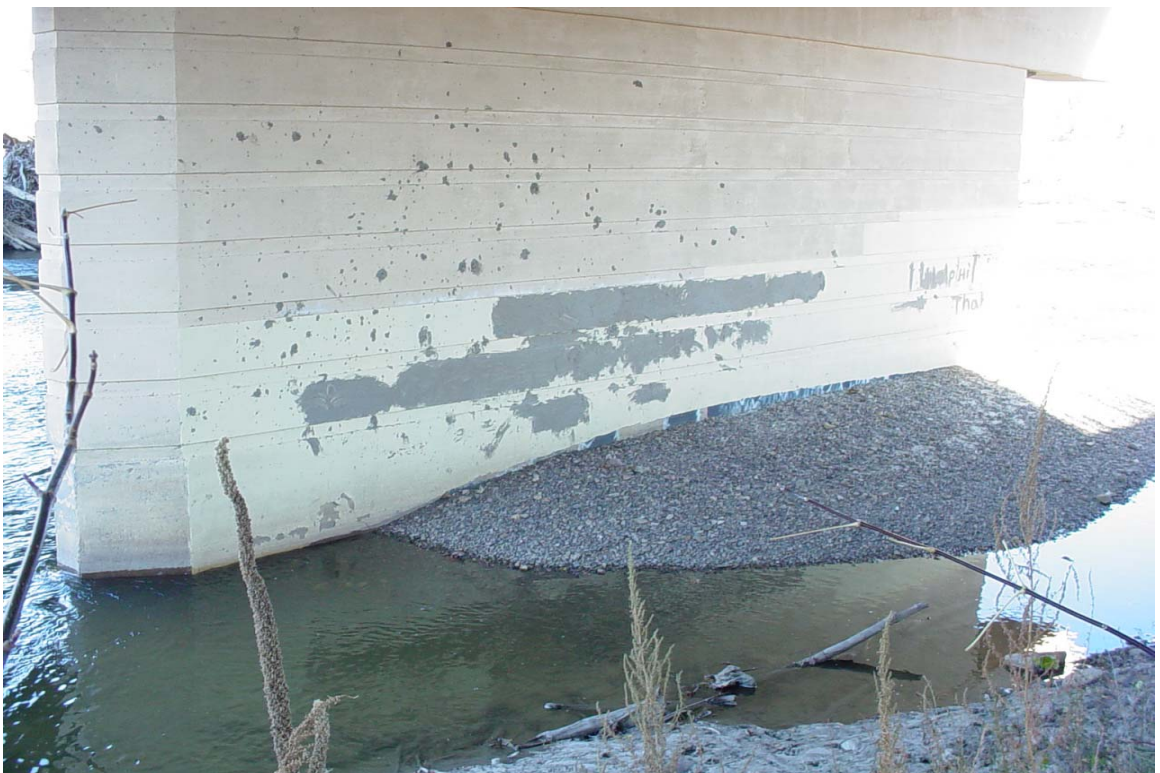
Photograph 4. View of Pier 4, Looking Southwest.

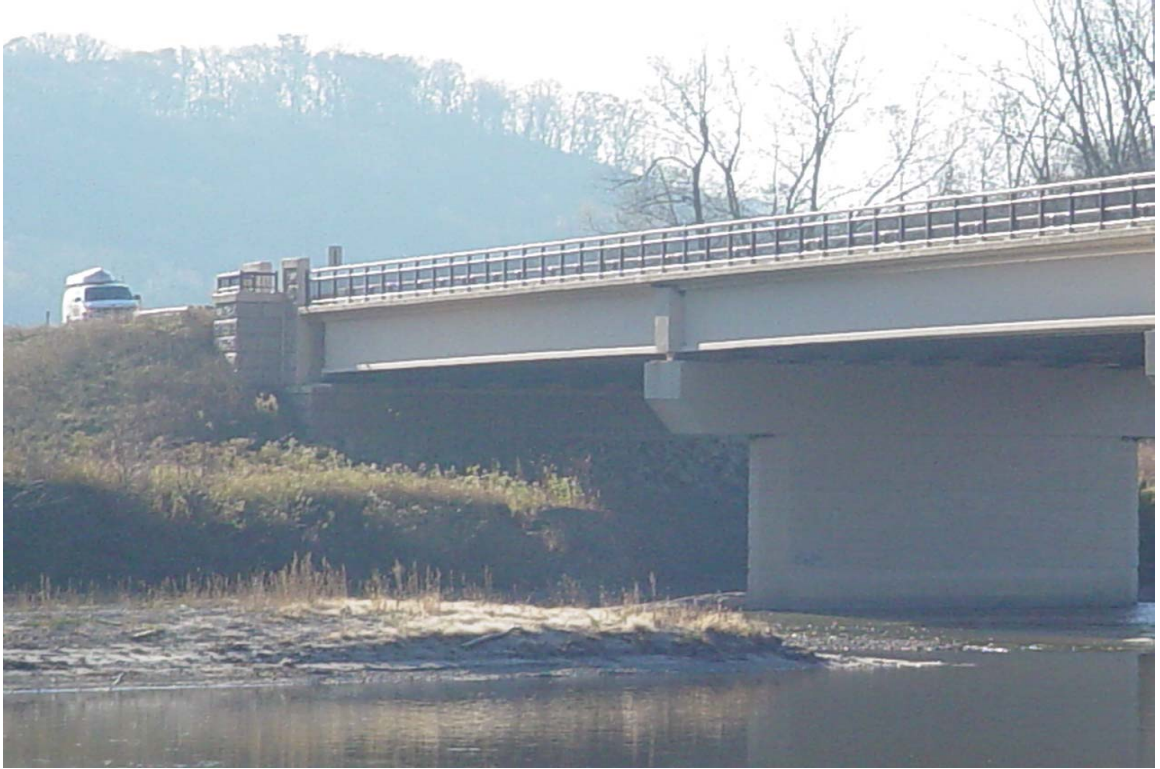
Photograph 5. View of Steep Vertical Erosion Along the East River Bank, Looking South.
